Clinical Realities

ACHIEVING ANTERIOR AESTHETICS IN THE GERIATRIC PATIENT USING FULL-COVERAGE METAL-CERAMIC CROWNS

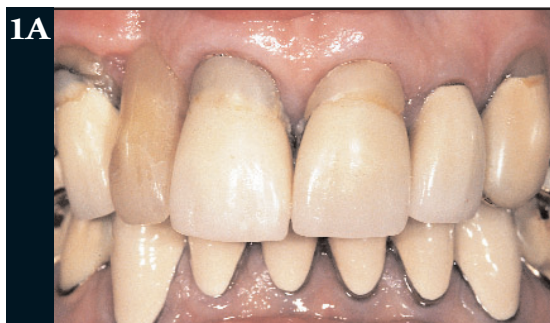
Figure 1A. Preoperative facial view of the existing removable partial denture. Note the soft tissue recession and severely compromised fit and aesthetics.

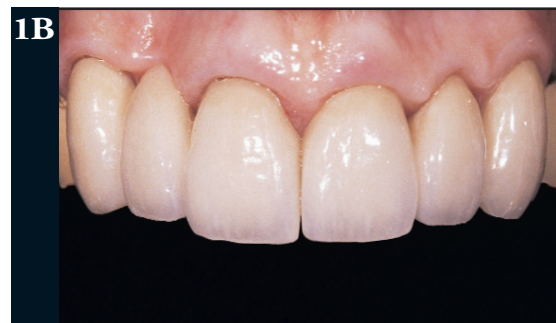
Figure 1B. Postoperative appearance of the definitive metal-ceramic crown restorations demonstrates significant aesthetic enhancement.

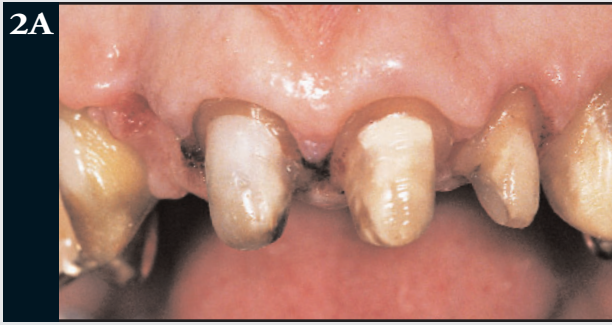
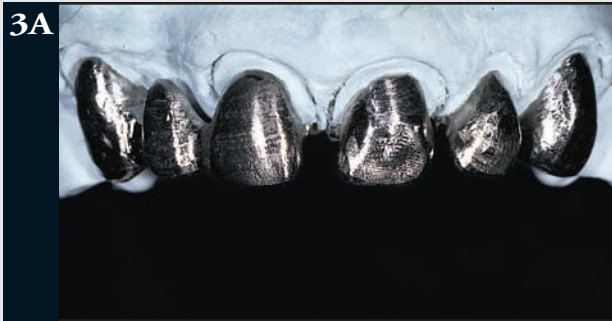
Figures 2A,B,C. Once the existing partial denture was removed, the patient's teeth were conservatively re-prepared to receive the full-coverage crowns. These restorations required a 1 mm to 1.2 mm chamfer reduction on the porcelain margin, 1.5 mm of facial reduction, and 1.5 mm to 2 mm of incisal reduction. Using a light-body, medium-viscosity polyvinylsiloxane impression material (ie, Twinz VPS, Bisco, Schaumburg, IL), the position of the dental and soft tissues were recorded for the laboratory technician. Provisional restorations were delivered to stabilize the intraoral environment and facilitate the evaluation of fit, aesthetics, phonetics, and occlusion.

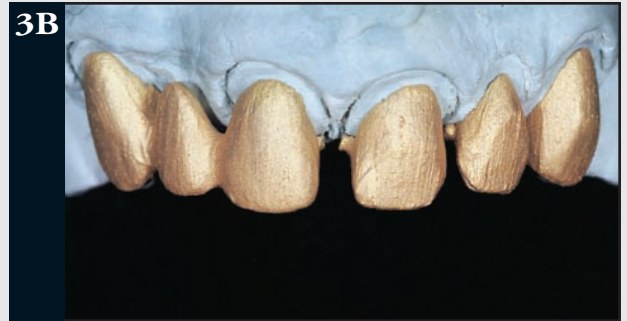
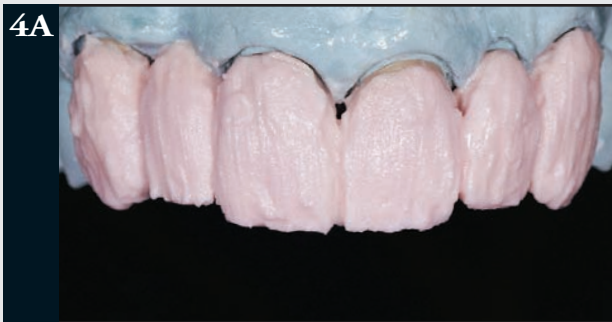
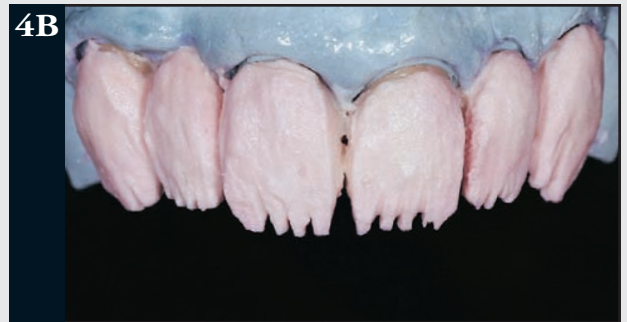
Figures 3A,B,C. The impression and related diagnostic information (eg, photographs, shade requirements) were forwarded to the dental laboratory. The models were poured, the metal substructures were created, then buildup was initiated. Two consecutive coats of gold were applied to the metal substructure. A thin layer of whitish opaque dentin was then applied to increase the value. This would compensate for the loss of value that would occur from multiple firings or the use of translucent powders. Vertical indentations were then placed in the dentin layer to reflect and scatter the light naturally.

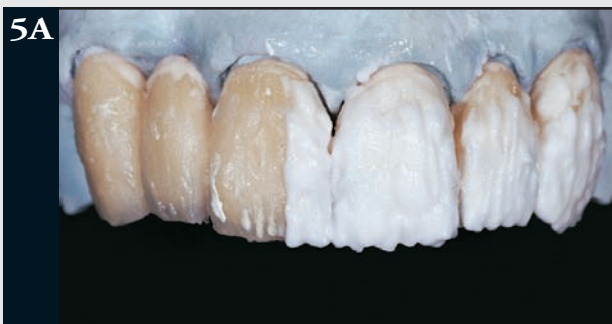
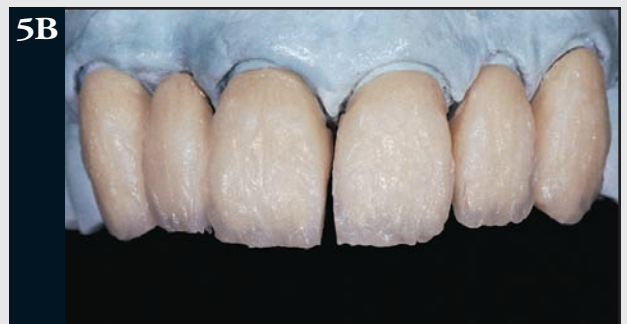
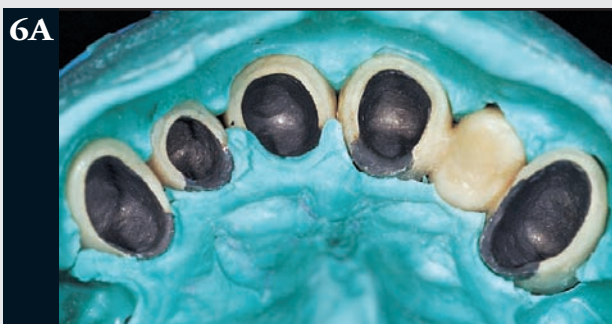
Figures 4A,B,C. Following the creation of the vertical indentations, the dentin layer was built up to full contour and the final shape of the restorations. Cutback was performed, and also provided sufficient space for the placement of enamel and translucent effects. Once these optical properties were rendered, the first firing of the dentin was performed at 900°C and held for 1 minute.
